Żerdziny, 19.08.2014.

Report on operation of heat recovery boiler cleaning system based on shock wave generators

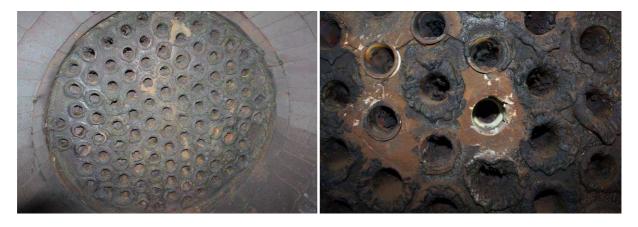
The main problem encountered during the first months of the sulphuric acid recovery plant operation was fouling of smoke tubes in 1^{st} and 2^{nd} pass of the heat recovery boiler. Boiler tubes on the process gas (flue gas) side were systematically fouled with fast sinter, originating from deposition of sodium sulphate, iron oxides – (II) and (III) and other salts. Such clogging with deposits in the boiler second pass appeared when alkali metals content in the post-refinery mixture was over 800 ppm. The clogging speed in the 2^{nd} pass in the aforementioned conditions was exponential and lasted from 1 to 4 days. Moreover, the applied addition of aluminium sulphate to the post-refinery mixture, which slowed down clogging in the boiler 1^{st} pass, resulted in accelerated clogging of the boiler 2^{nd} pass, consequently rendering impossible longer operation of the entire plant.

Photo 2. Smoke tube with deposits restricting flu gas flow to the boiler 1st pass.

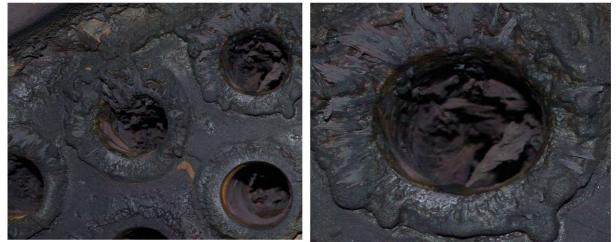
In May, 2014, before installing the cleaning system based on the shock wave technology, an inspection of the boiler had been carried out with regard to fouling of the 1st and 2nd pass smoke tubes. Boiler shutdown for manual cleaning was caused by total clogging of the flue gas flow in the high temperature zone in its first pass. The area of the flue gas inlet to the heat recovery boiler is shown in photos 2 and 3.

Photo 3. Fouled smoke tubes in the heat recovery boiler first pass.

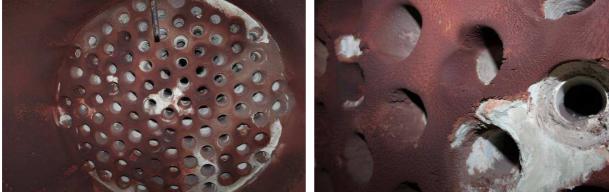
In the second pass and intermediate header there were fine deposits on all surfaces. The outlet tube sheet of the first pass was covered with a thick layer of deposits, which did not restrict the flue gas flow.

Photo 4. Thick layer of fine deposits on the tube sheet at the first pass flue gas outlet.

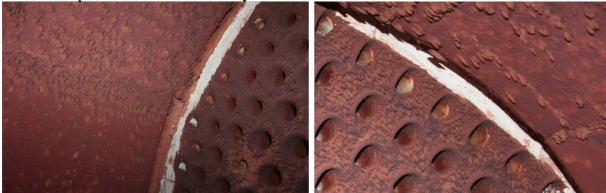
Fine deposits were also observed on the intermediate header walls, which connects the first and second passes of the heat recovery boiler.

Photo 5. Intermediate header, which joins the first and the second pass of the heat recovery boiler, with its walls covered with deposits.

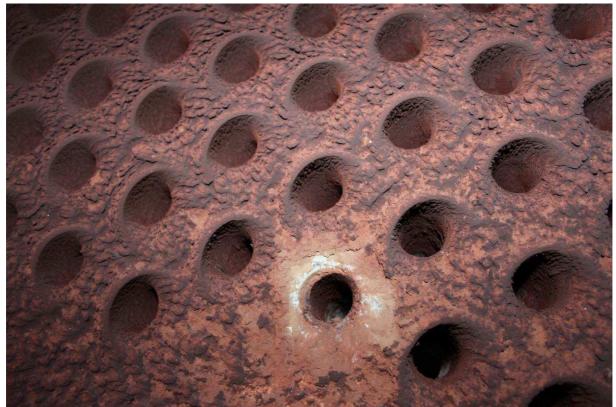
In the second pass of the heat recovery boiler, a thick deposit layer was detected on the tube sheet, showing the tendency to restrict the flue gas flow. These deposits were fine ones and easy to remove. The phenomenon of the smoke tube clogging was intensified by a concrete layer, which protected the metal tube sheet against high-temperature corrosion.

Photo 6. Second pass inlet tube sheet covered with deposits.

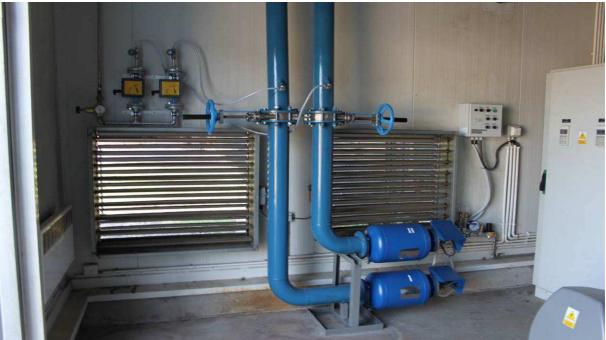
Photo 7. Two GFU-24/8 shock wave generators, located in the electrostatic precipitator room.

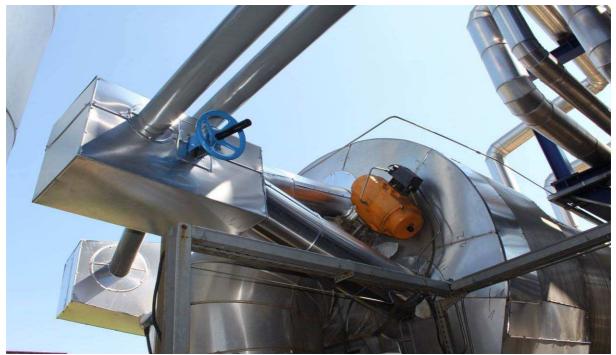
Photo 8. Shock wave inlet for smoke tube cleaning.

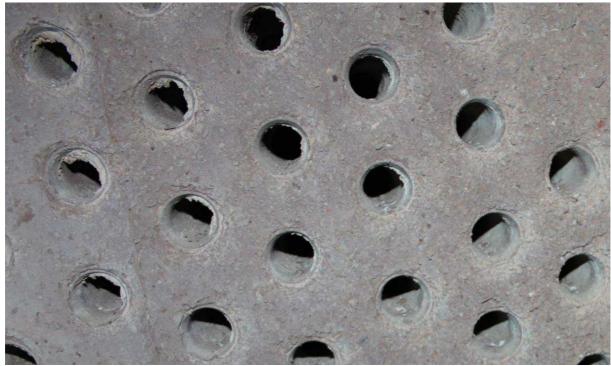
Following the continuous operation for 21 days, the sulphuric acid recovery plant was shut down for internal revision on 14 July, 2014. The fouling degree of the first and second passes was such that further operation of the plant was still possible. The shock wave, released by the generators, had systematically been removing deposits in the entire plant, particularly from the second pass of the heat recovery boiler. During the revision on 14 July, 2014, decreased quantities of deposits were observed on the first pass outlet tube sheet and the intermediate header walls. The smoke tubes in the boiler second pass were free from deposits restricting the flue gas flow. Additionally, pressure measurements, taken upstream and downstream the smoke tube exchanger second pass, showed no flue gas flow resistances. In the course of the revision no damages were detected concerning the brickwork on the tube sheets or intermediate headers walls. During the operation of the sulphuric acid recovery plant no influence of the shock wave on the operational parameters was observed. As had been expected earlier, the impact of the shock wave and cleaning was seen not only on the second pass but also on the intermediate header and outlet tube sheet of the first pass.

Photo 9. Inlet tube sheet to the second pass cleaned in counter-current by shock wave.

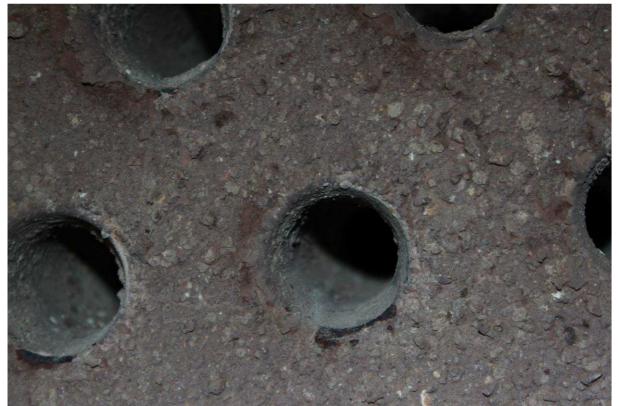
Photo 10. Smoke tubes with no fine deposit at all.

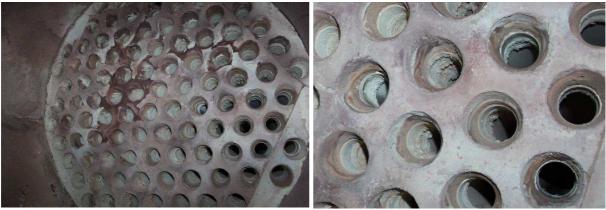
During the three-week operation of the cleaning system based on the shock wave generators, we observed the additional effect of decreased amount of deposit on the intermediate header walls and the first pass outlet tube sheet. Some insignificant amount of hard deposit was only found on the bottom of the intermediate header, which most probably resulted from additional cleaning of the first pass from hard deposits, forming at the smoke tube inlet.

Photo 11. Additional cleaning effect using shock wave. The first pass outlet tube sheet with no deposits restricting flue gas flow.

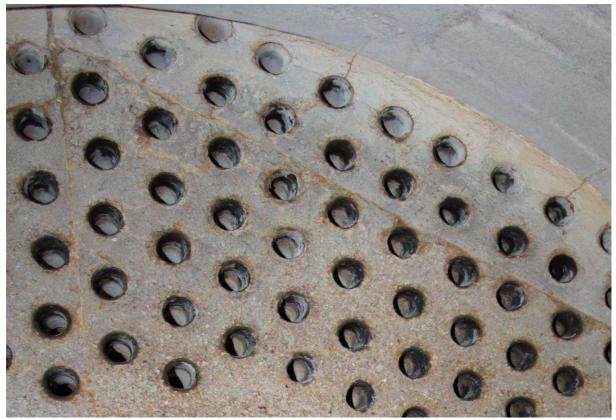
After entering the boiler it was fond out that owing to the action of the shock wave the second pass, the intermediate header and the first pass tube sheet were completely cleaned. No negative impact of the shock wave was noticed on the tube sheet brickwork or intermediate header walls. No damages to the steel profiles at the inlet to the smoke tubes between the first and second pass were found, either. Similarly to the first inspection, on the bottom of the intermediate header there was some small amount of solid/hard deposit from the first pass. In our opinion, the released shock wave cleans in the counter-current very effectively five-meter long tubes of the smoke tube exchanger. During the revision of the heat recovery boiler second pass and following another twelve days, no fine deposits were observed. At this stage, we confirm one-hundred per cent effectiveness of the GFU-24/8 shock wave generators in cleaning of the heat recovery boiler second pass.

Photo 12. Upper part of the second pass tube sheet with no fine deposits at all.

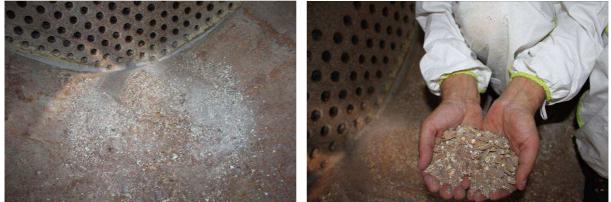
Photo 13. Insignificant quantities of hard deposits on the bottom of the intermediate header, which are systematically removed from the first pass.

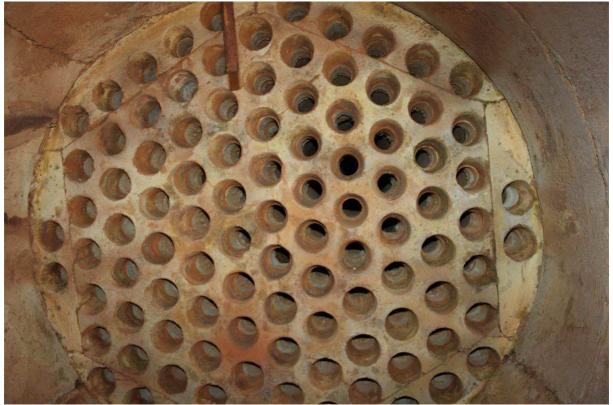
Photo 14. Completely cleaned concrete outlet tube sheet of the heat recovery boiler first pass. It is the additional effect of the shock wave action.

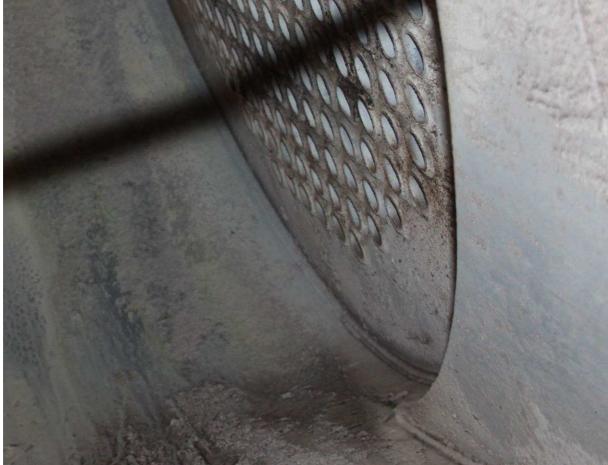
In the course of the revision, no negative impact of the shock wave on the outlet header walls was observed. In this area no deposits whatsoever were noticed. Both the outlet header and the smoke tubes are kept in high degree of cleanness.

Photo 15. The flue gas outlet header downstream the heat recovery boiler with visible two inlets of the shock wave.
